# **STRUCTURAL BEHAVIOUR OF HISTORIC MASONRY CROSS VAULTS**

A thesis submitted for the Degree of Doctor of Philosophy

School of Civil and Enviromental Engineering  
The University of Edinburgh

An experimental and theoretical study for the assessment of the safety of cross vaults is presented in this thesis. The case study is based on an aisle vault from the partially collapsed Abbey Church of Holyrood, Edinburgh. A replica in 1/4-scale was built reproducing this ribbed vault, which has straight vertices and was made of rubble masonry.

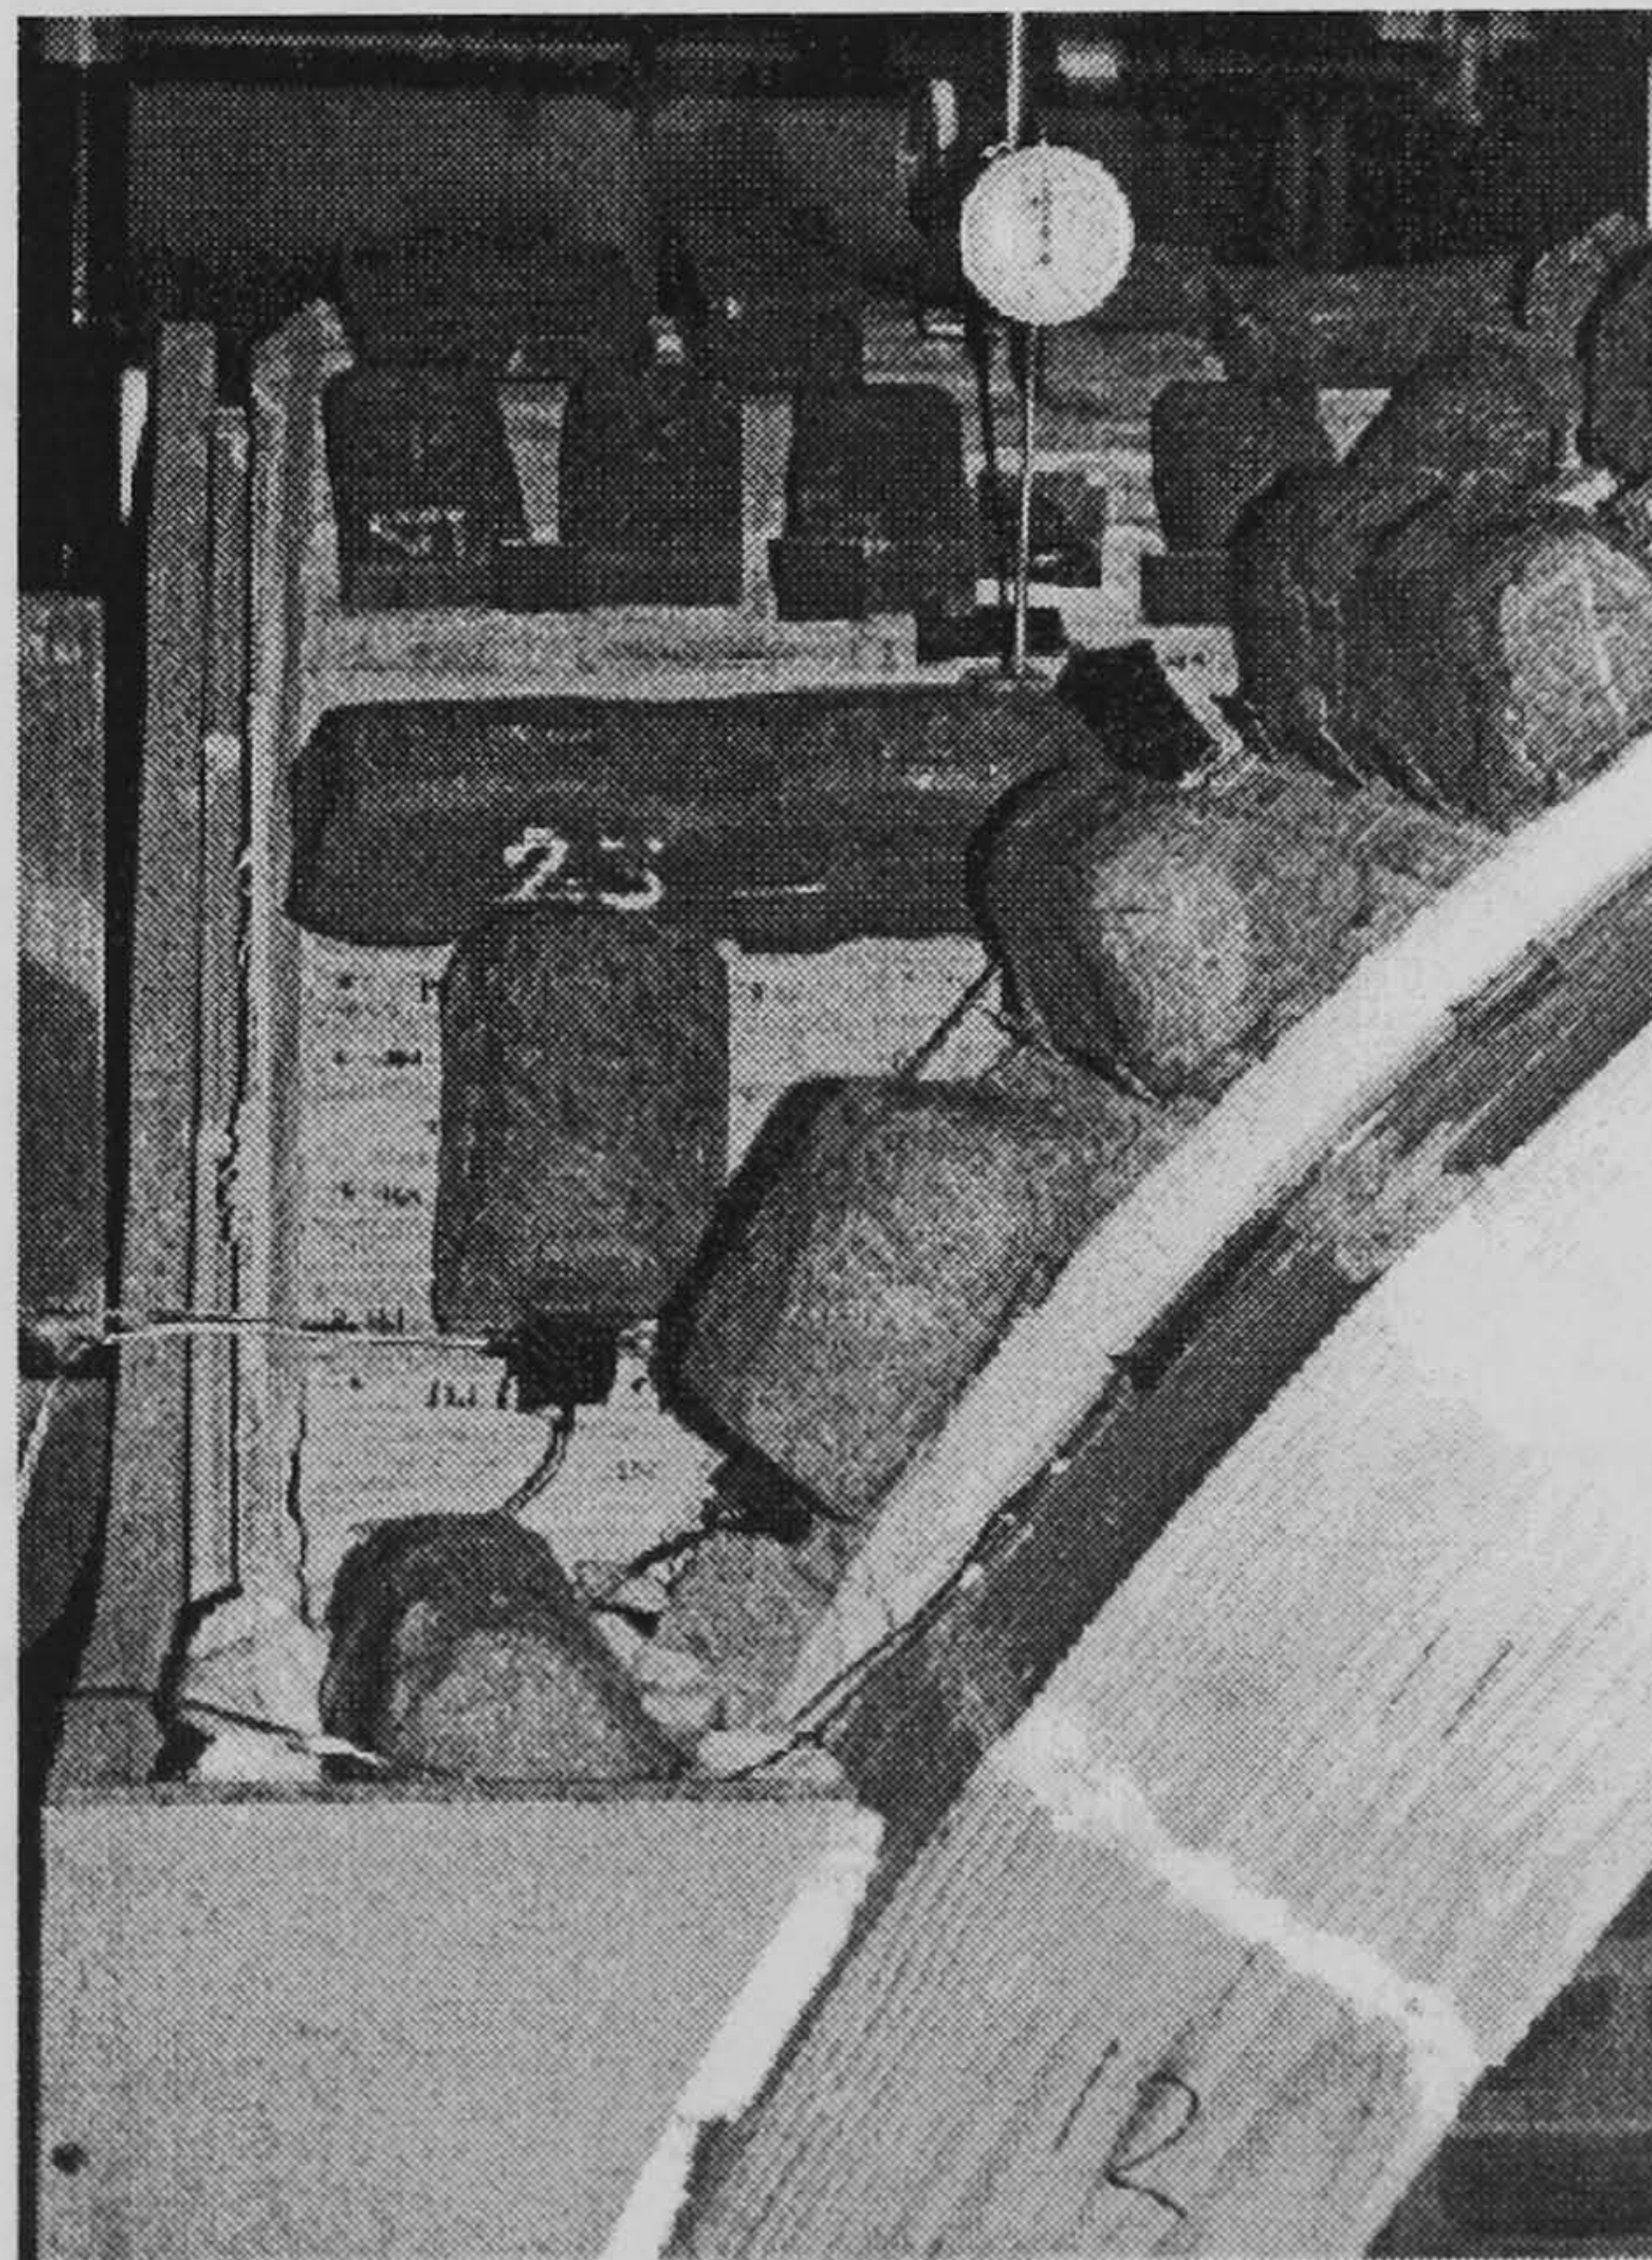
FIGURE 4.9 Spandrel wall and fill

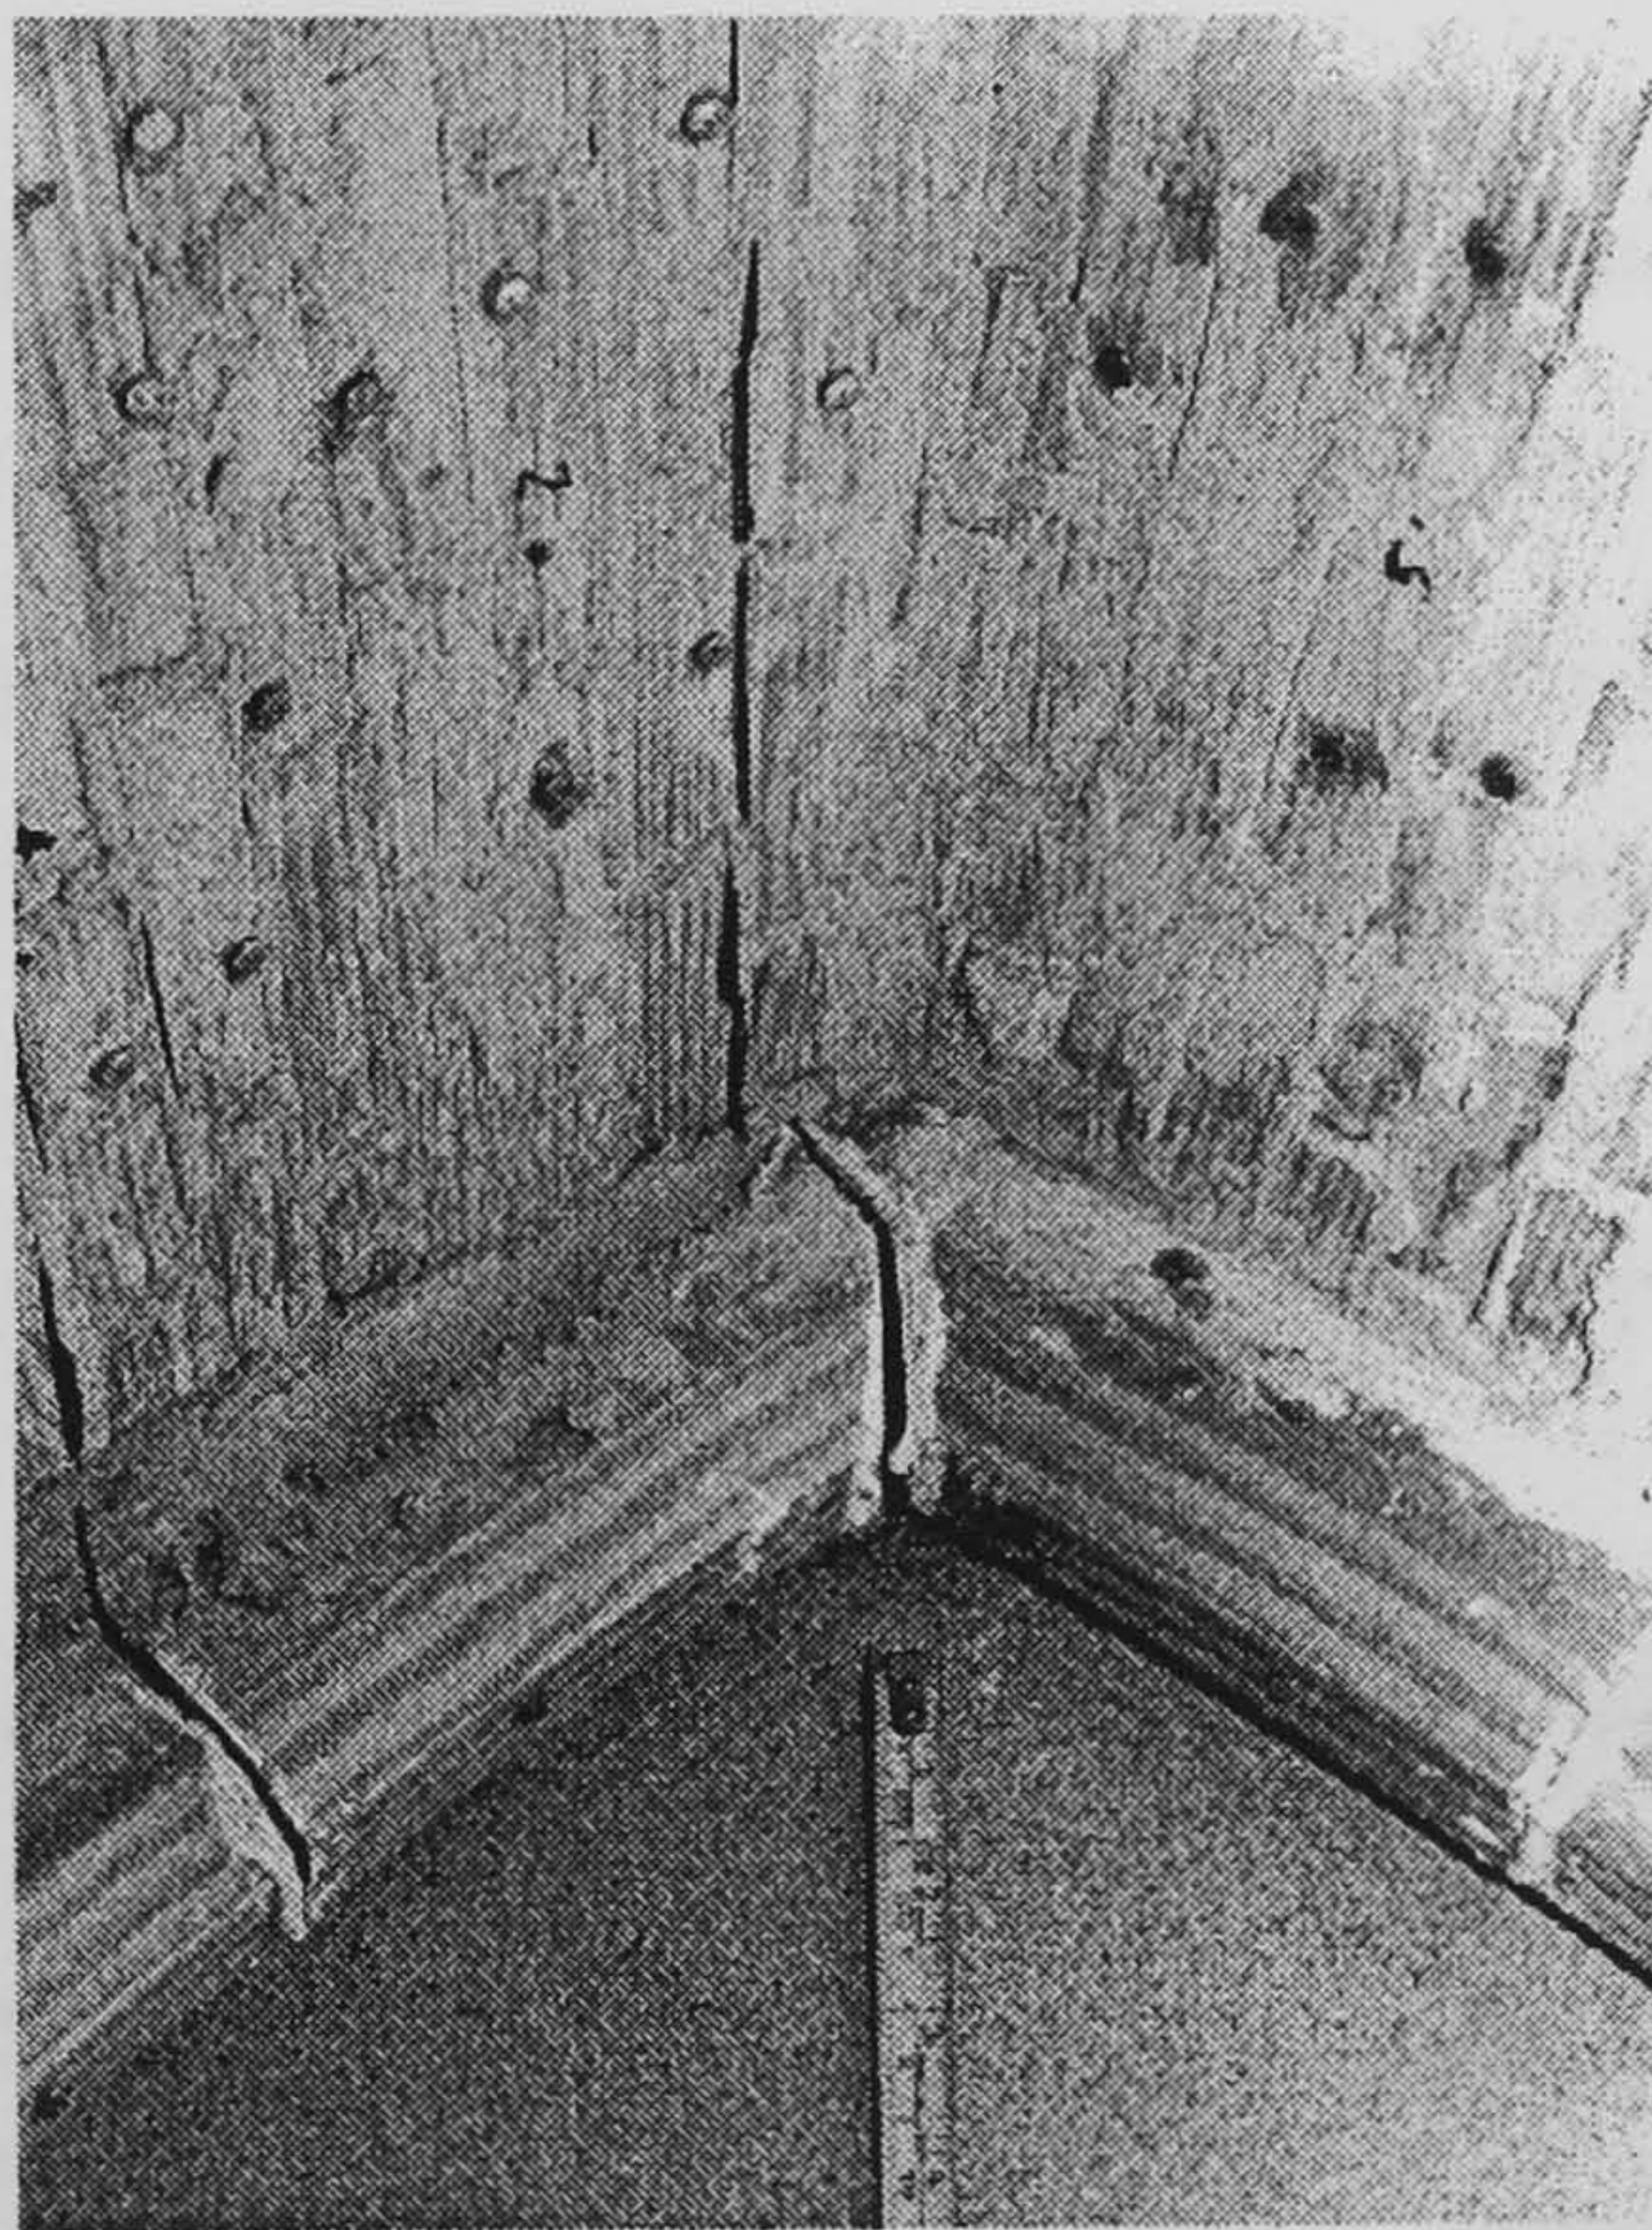
FIGURE 6.6 Crack at the crown of the transverse arch
